THERMOMECHANICAL FATIGUE
CHARACTERIZATION OF AN ANGLE PLY
METAL MATRIX COMPOSITE

THESIS

Wade H. Vaught, First Lieutenant, USAF

**In Partial Fulfillment of the
Requirements for the Degree of
Master of Science in Aeronautical Engineering**

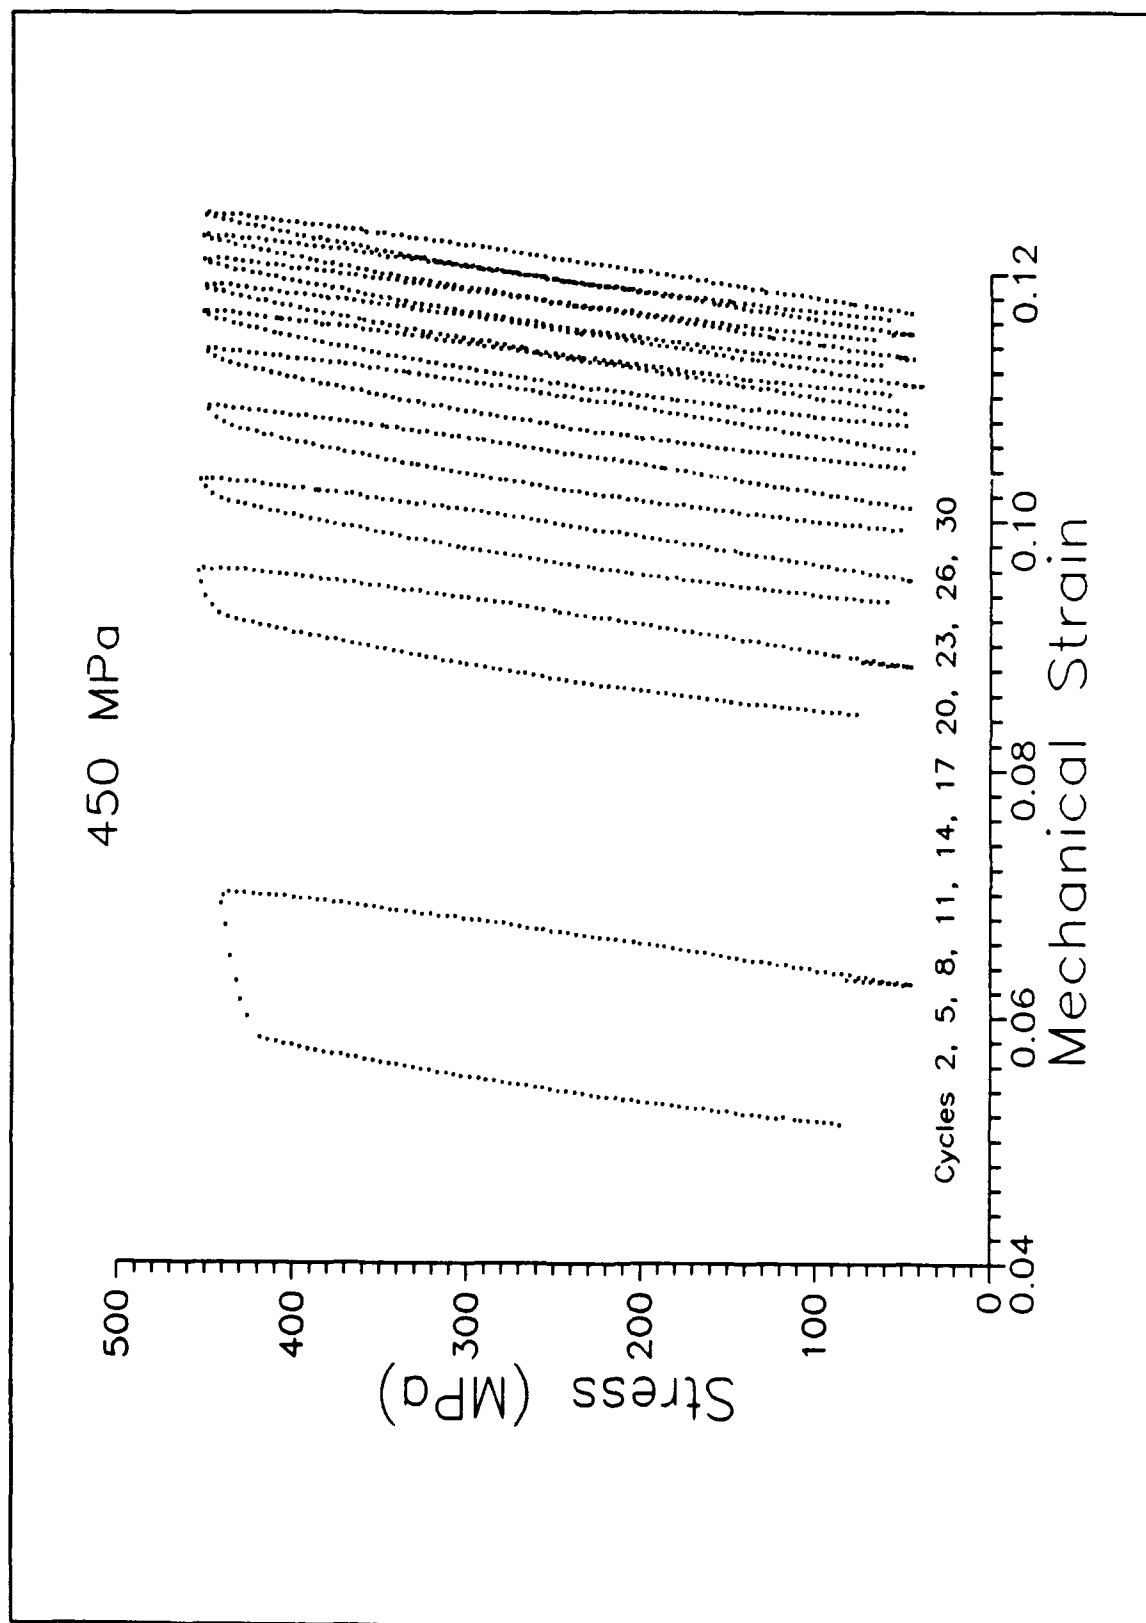
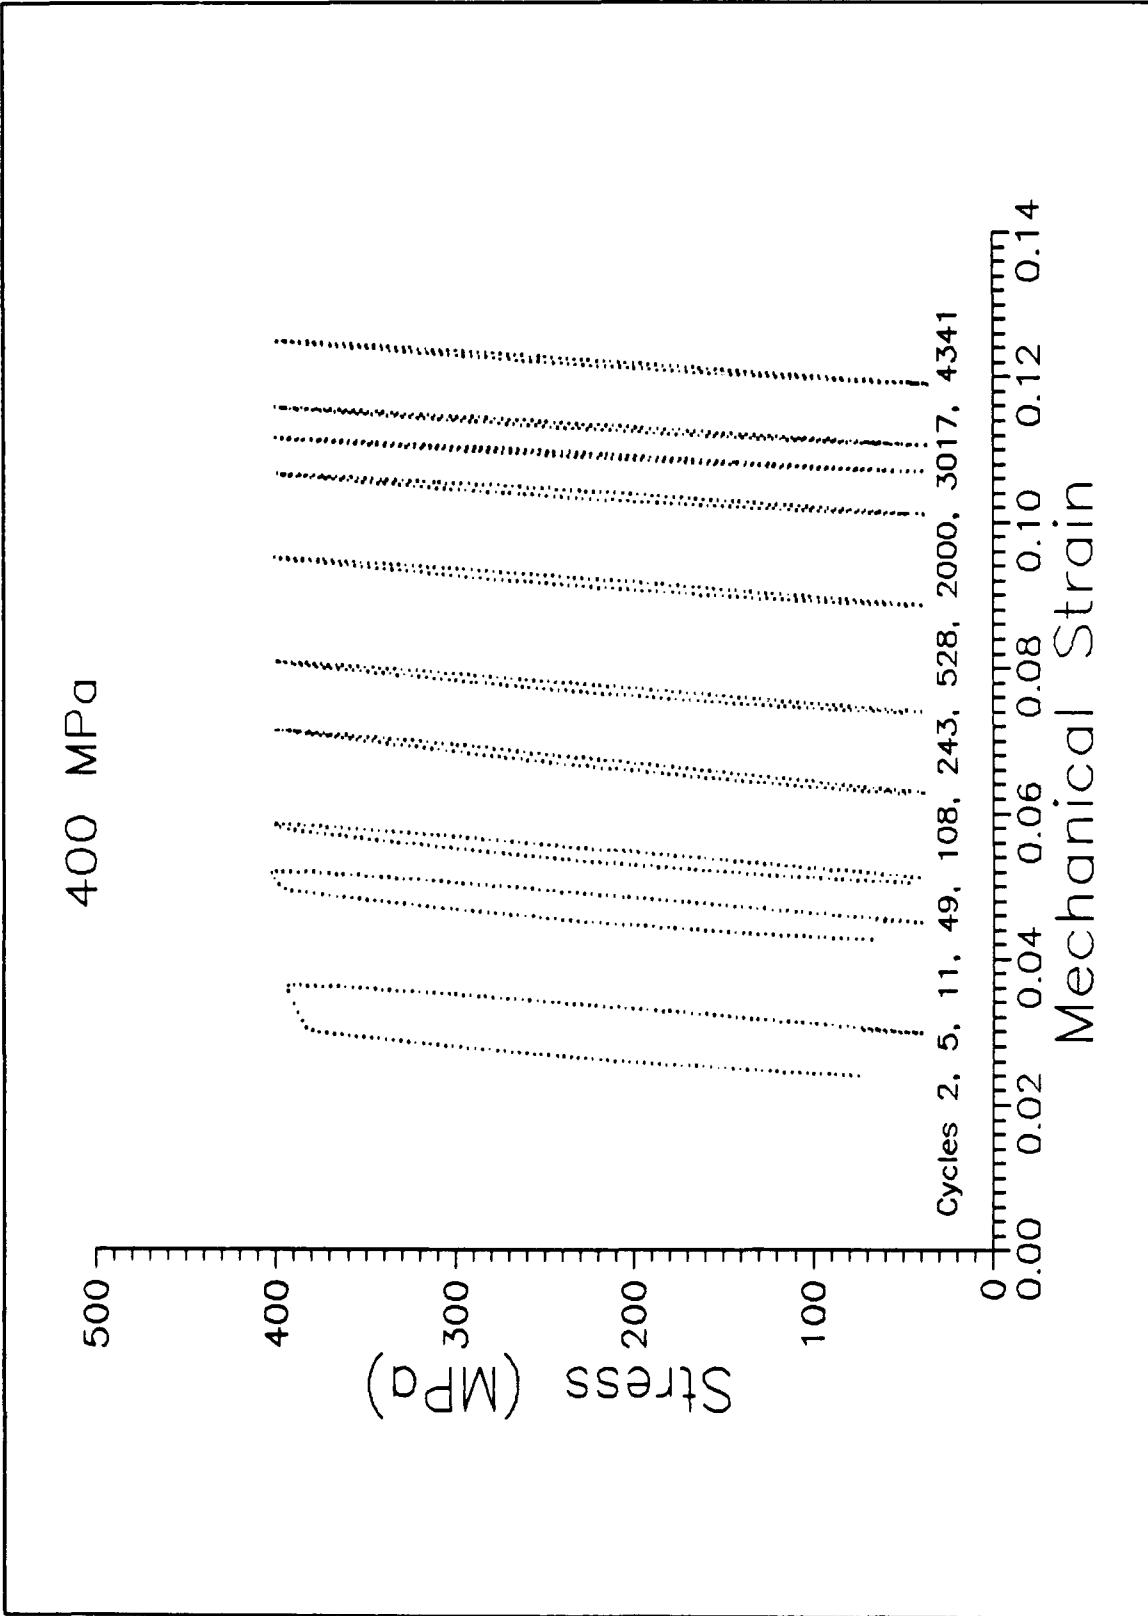
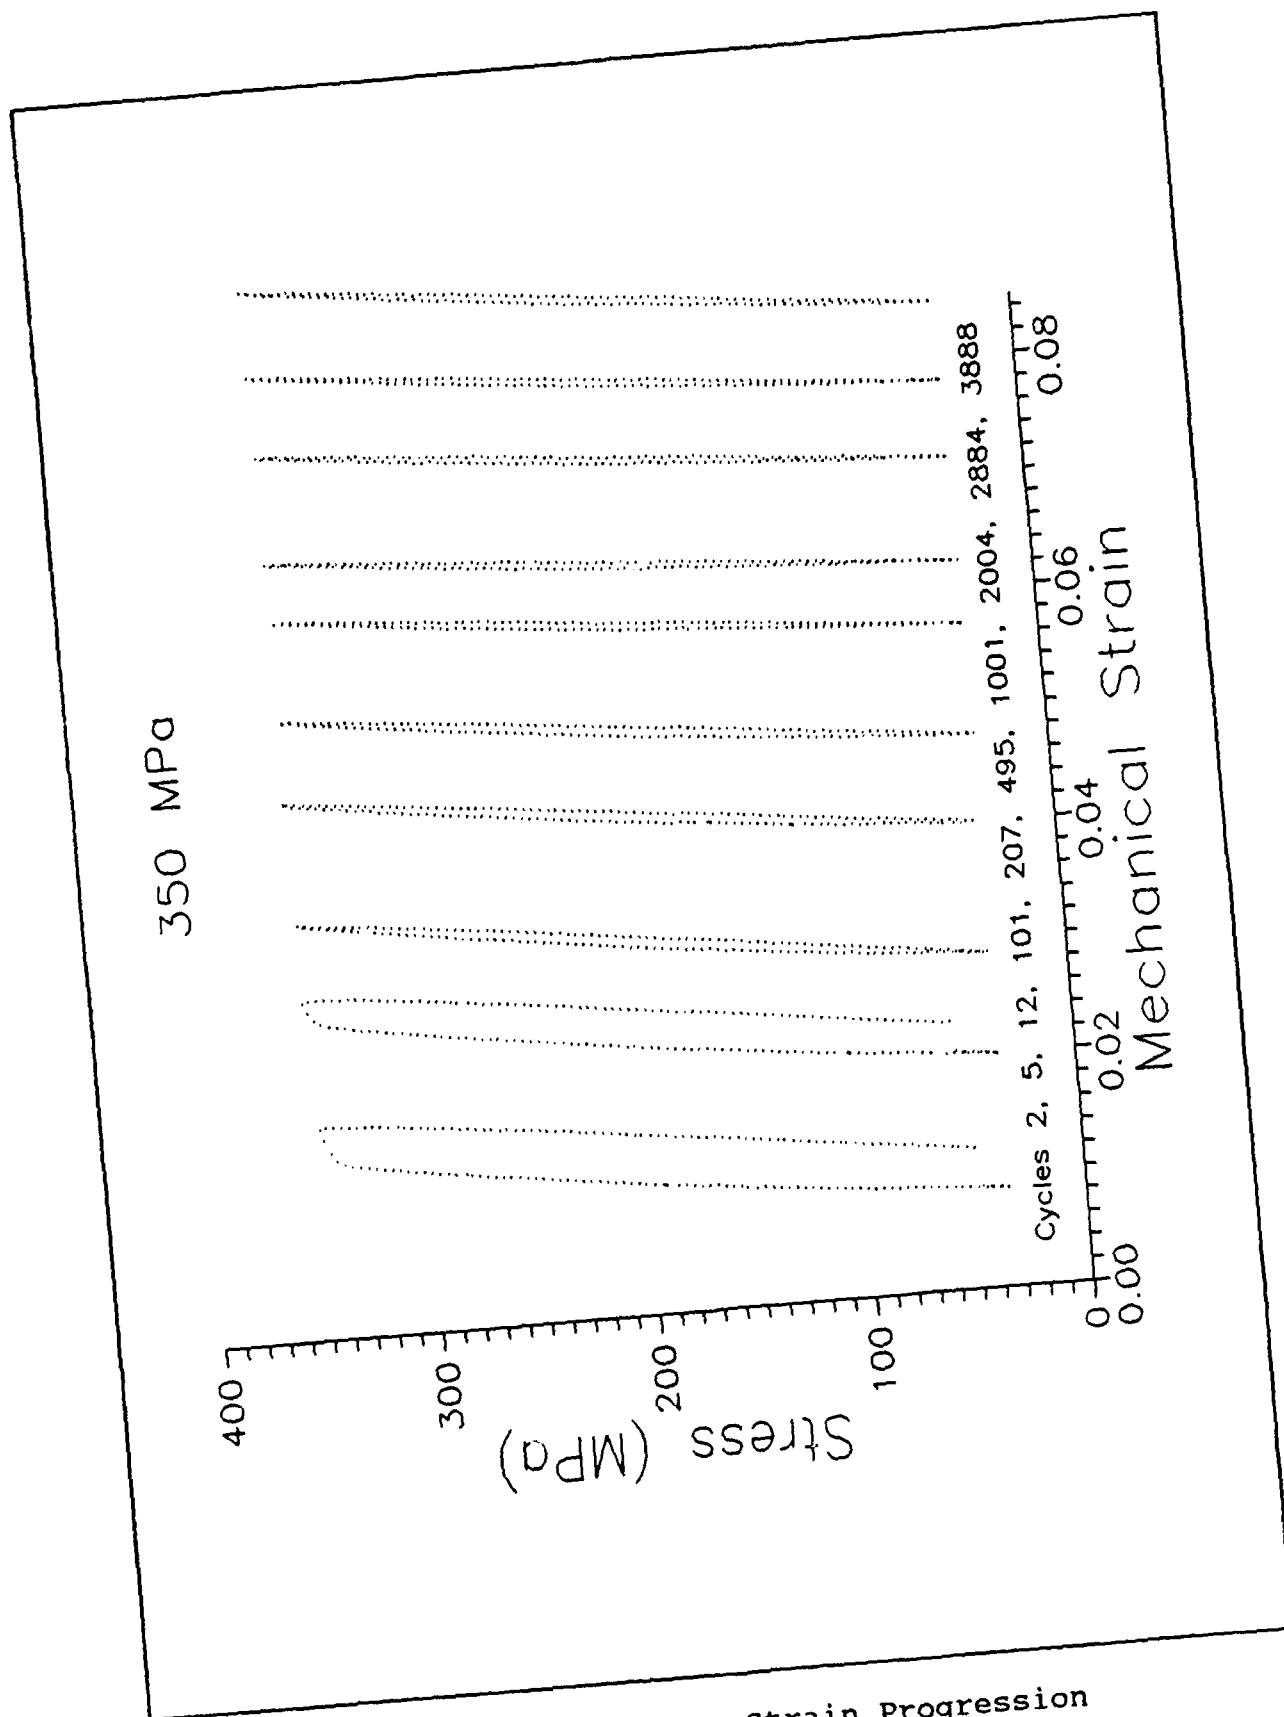
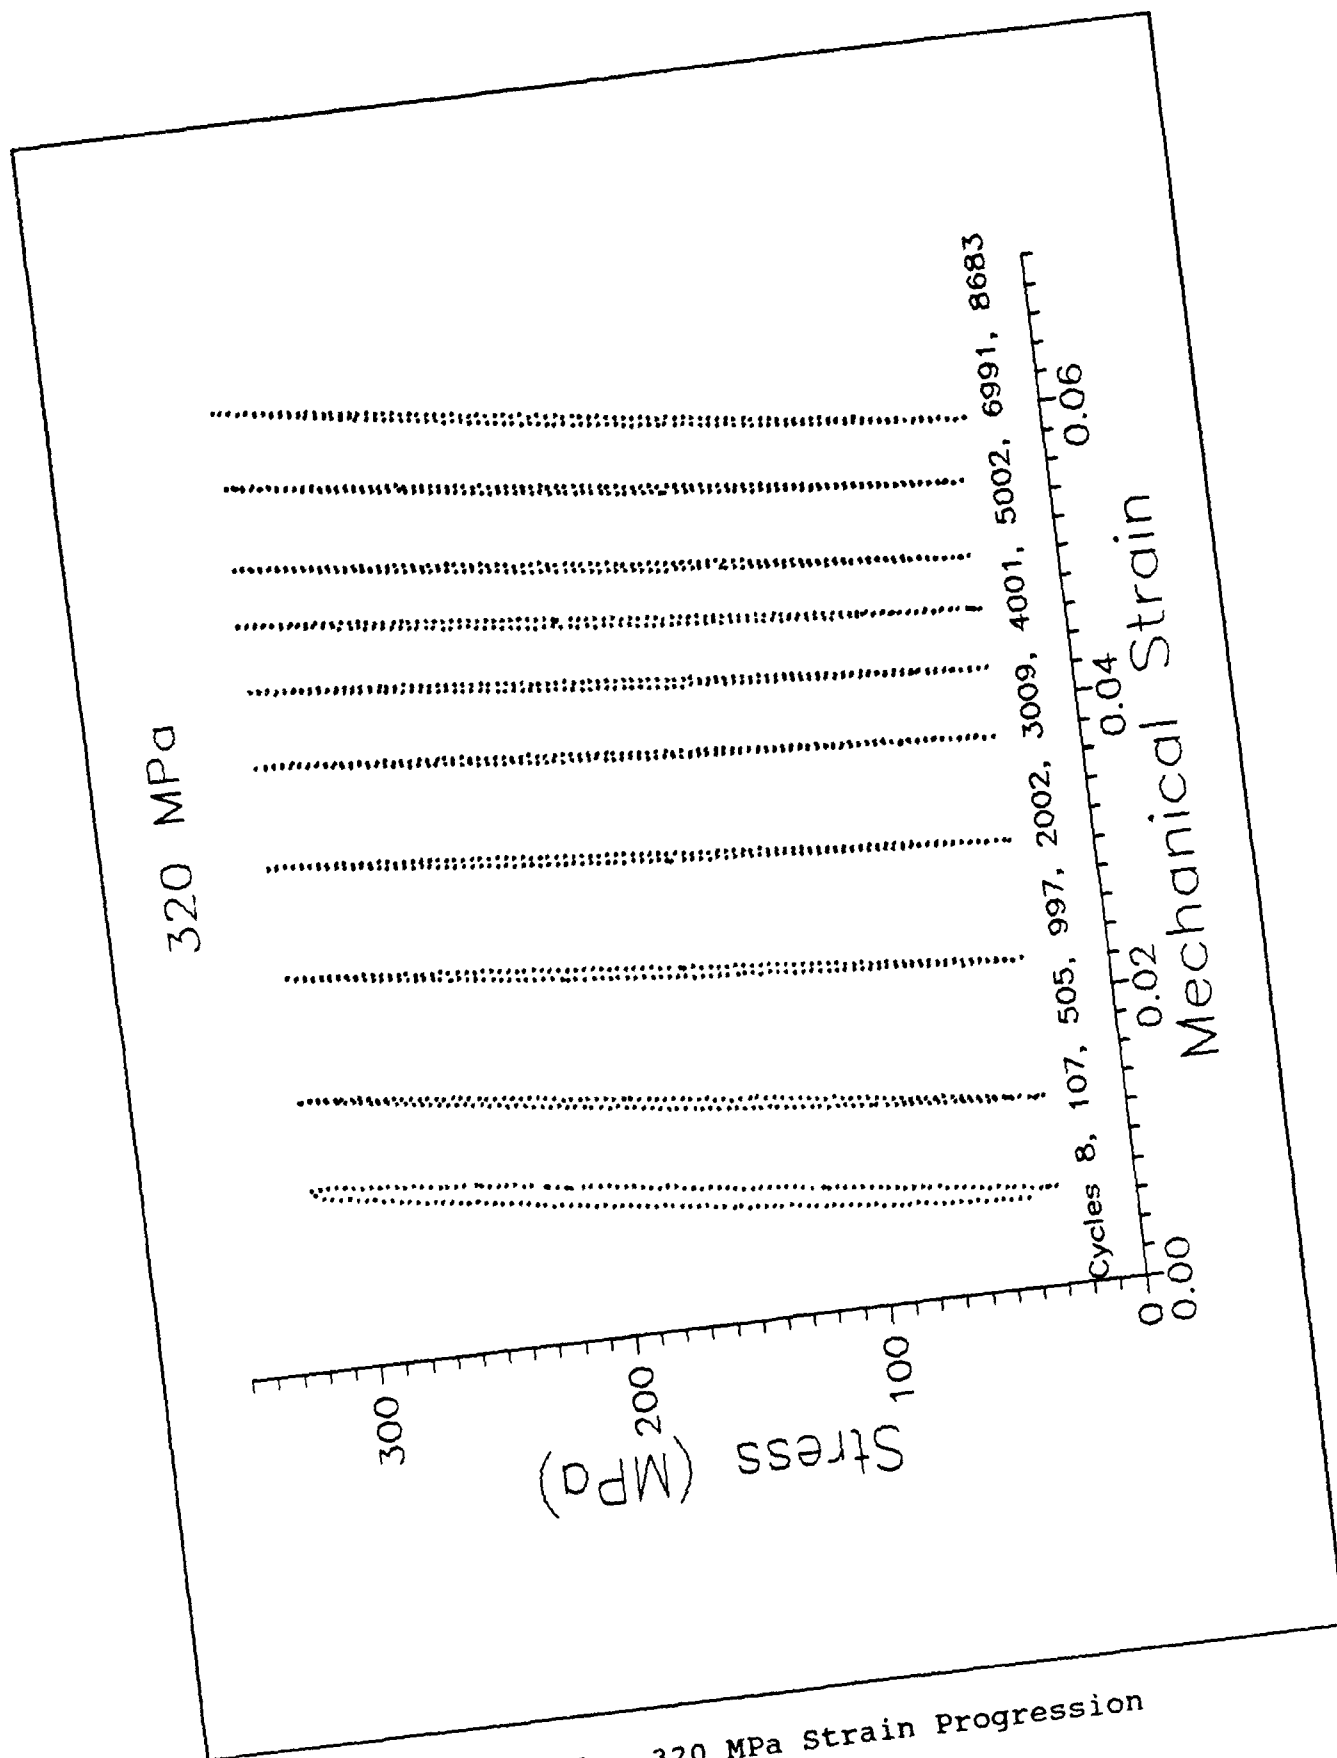
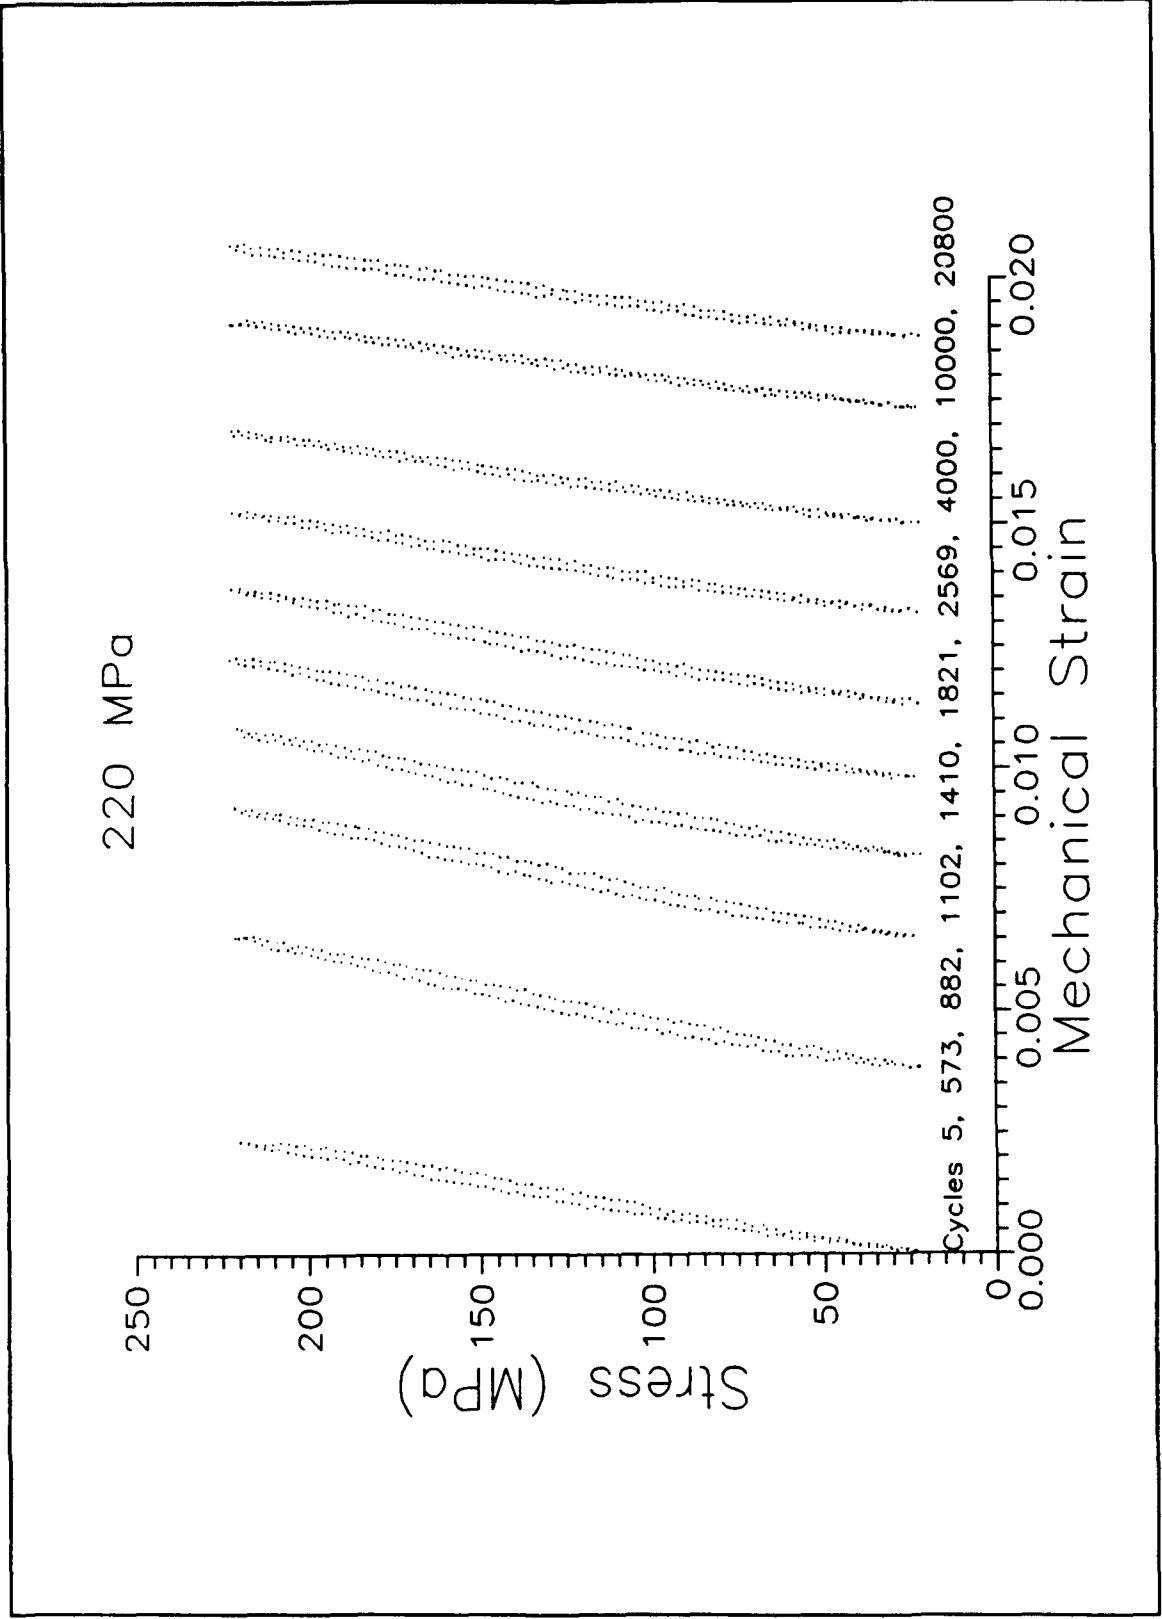
Figures 18 through 22 show the strain progression for selected cycles for all specimens tested. The figures show graphically the strain ratchetting occurring in each test. Here again the disproportionate amount of strain accumulation in the early cycles is evident. The second cycle for the 450 MPa, 400 MPa and 350 MPa tests shows extensive plastic yielding. It can be assumed from the isothermal fatigue data that similar, if not greater, plastic deformation occurred during the first cycle of these tests. Each test revealed stress-strain hysteresis which continued to failure. The width of the hysteresis was greatest during the first twelve cycles, but rapidly decreased after that and remained relatively stable for the remainder of the

Figure 18. 450 MPa Strain Progression

Figure 19. 400 MPa Strain Progression

Figure 20. 350 MPa Strain Progression

Figure 21. 320 MPa Strain Progression

Figure 22. 220 MPa Strain Progression

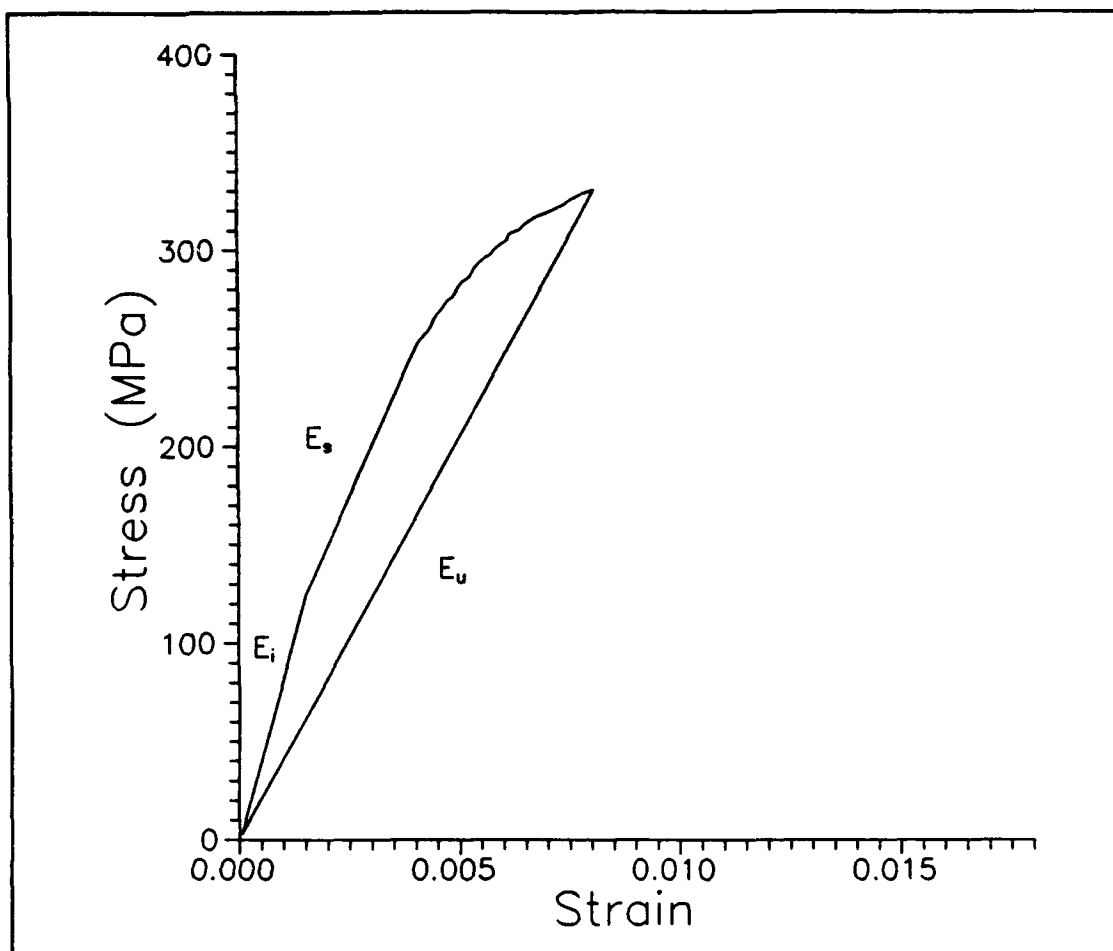
The modulus of a material can be a useful parameter when attempting to quantify damage through a change in stiffness. Due to the bi-linear response of the composite used in this study and the constant stress-strain hysteresis, a single modulus does not fully describe the mechanical response of the laminate. Instead, three modulii were used to describe the stiffness loss related to the damage accumulation during cycling. Figure 23 is an idealized schematic of a typical stress-strain curve observed during TMF cycling. The three modulii used are shown in the schematic. E_1 is the initial loading modulus, E_2 is the secondary loading modulus and E_u is the unloading modulus. A knee upon unloading, corresponding to closure of fiber-matrix debonding, was occasionally observed. The stiffness,

Figure 23. Idealized Schematic of a Typical Stress-Strain Curve

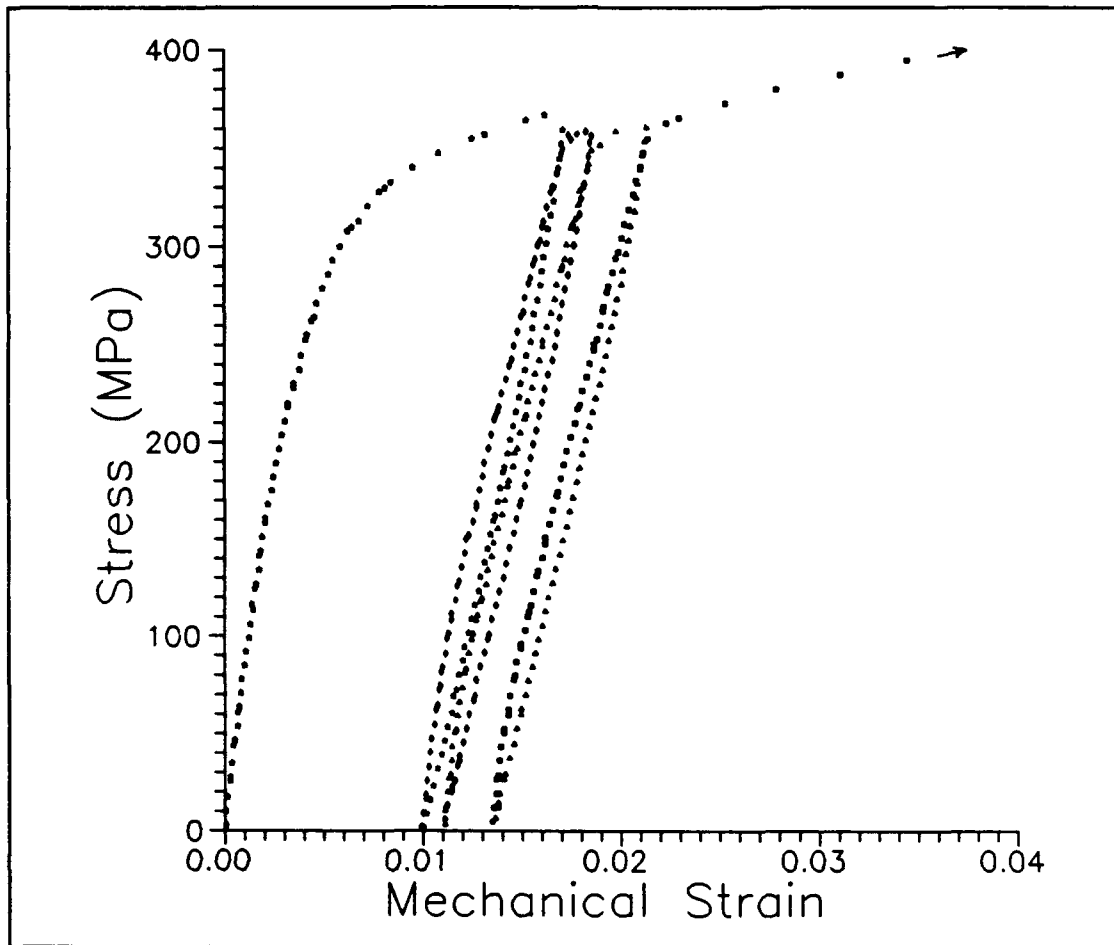
The calculated moduli show distinct trends from cycle to cycle. Both loading moduli, E_1 and E_s , decrease for each consecutive cycle, showing the effect of damage. The unloading modulus stabilizes after the first cycle and seems related to the secondary loading modulus. Though the unloading knee and bi-linear response are not obvious upon unloading, the physical phenomenon which causes this behavior is still occurring. This can be seen in the loading response during the subsequent cycle. The initial loading modulus is much higher than the unloading modulus from the previous cycle, yet after the knee, the secondary loading modulus equals the unloading modulus from the previous cycle. This implies that the fiber-matrix bond is being re-established during the unloading portion and subsequently relaxed during the loading portion of the next cycle. The

Figure 24. Stress-Strain Data for IF Test

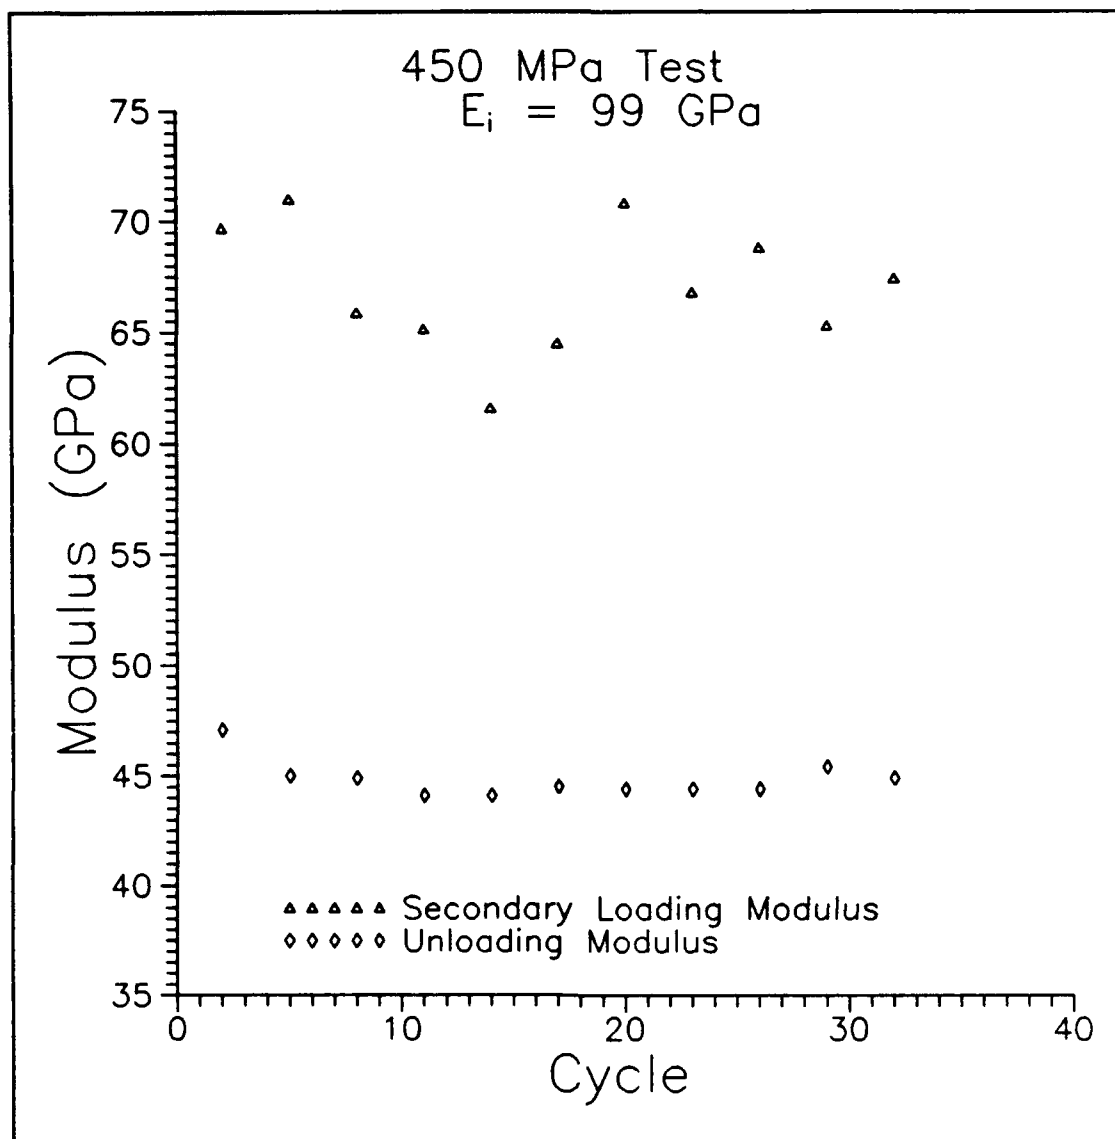
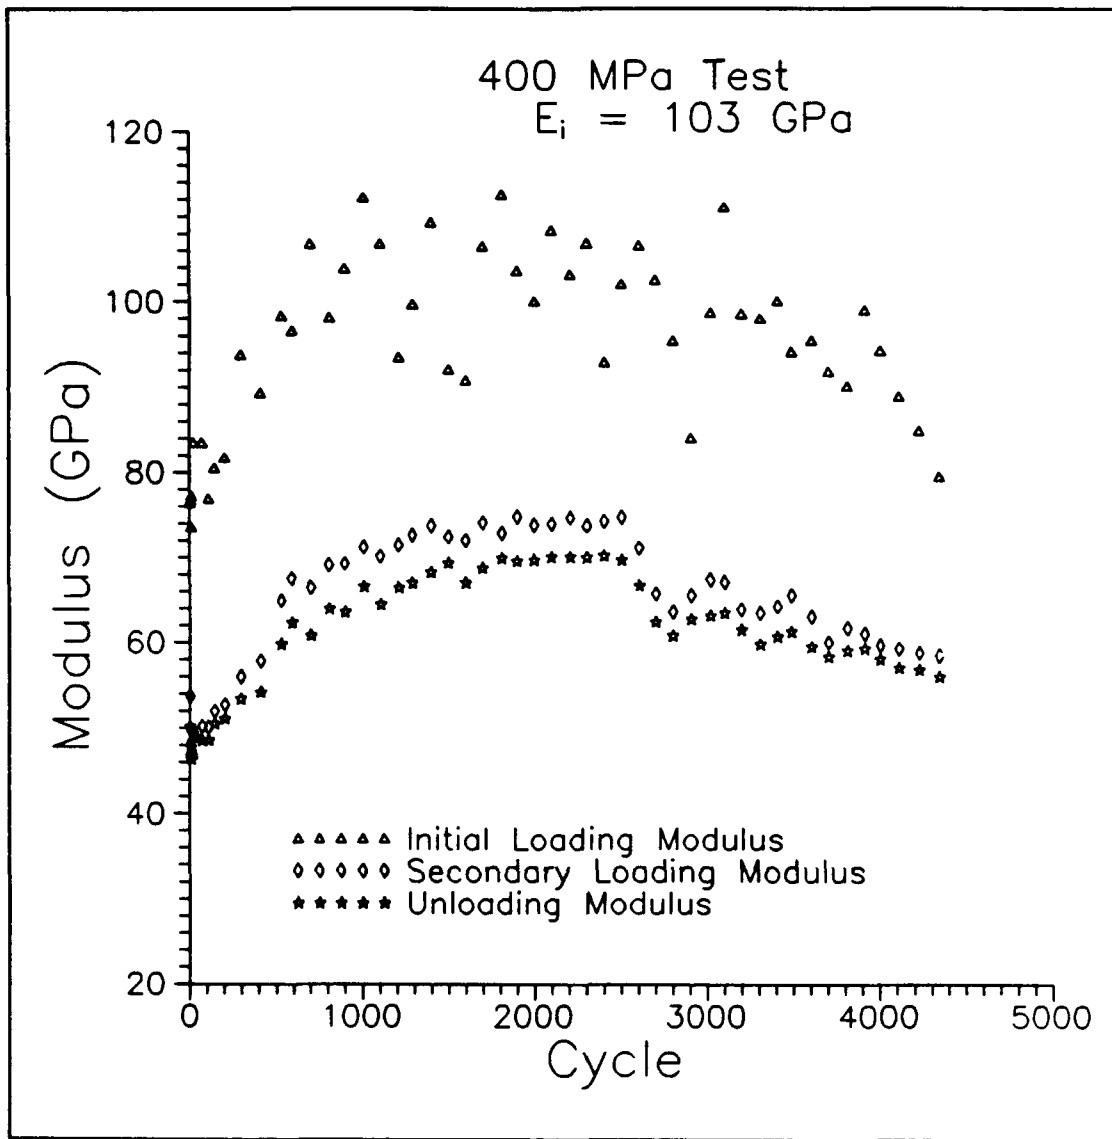
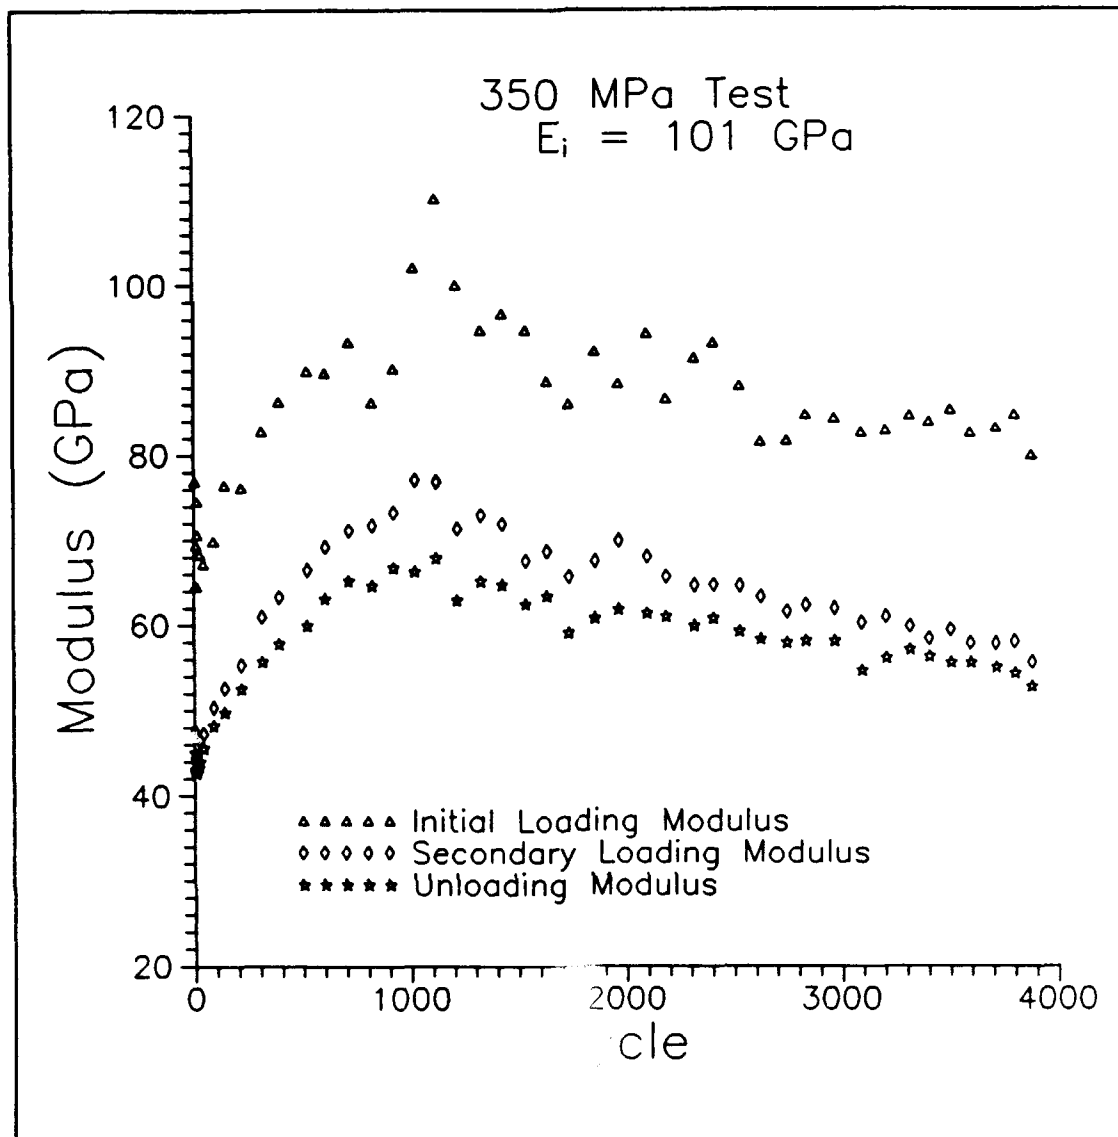
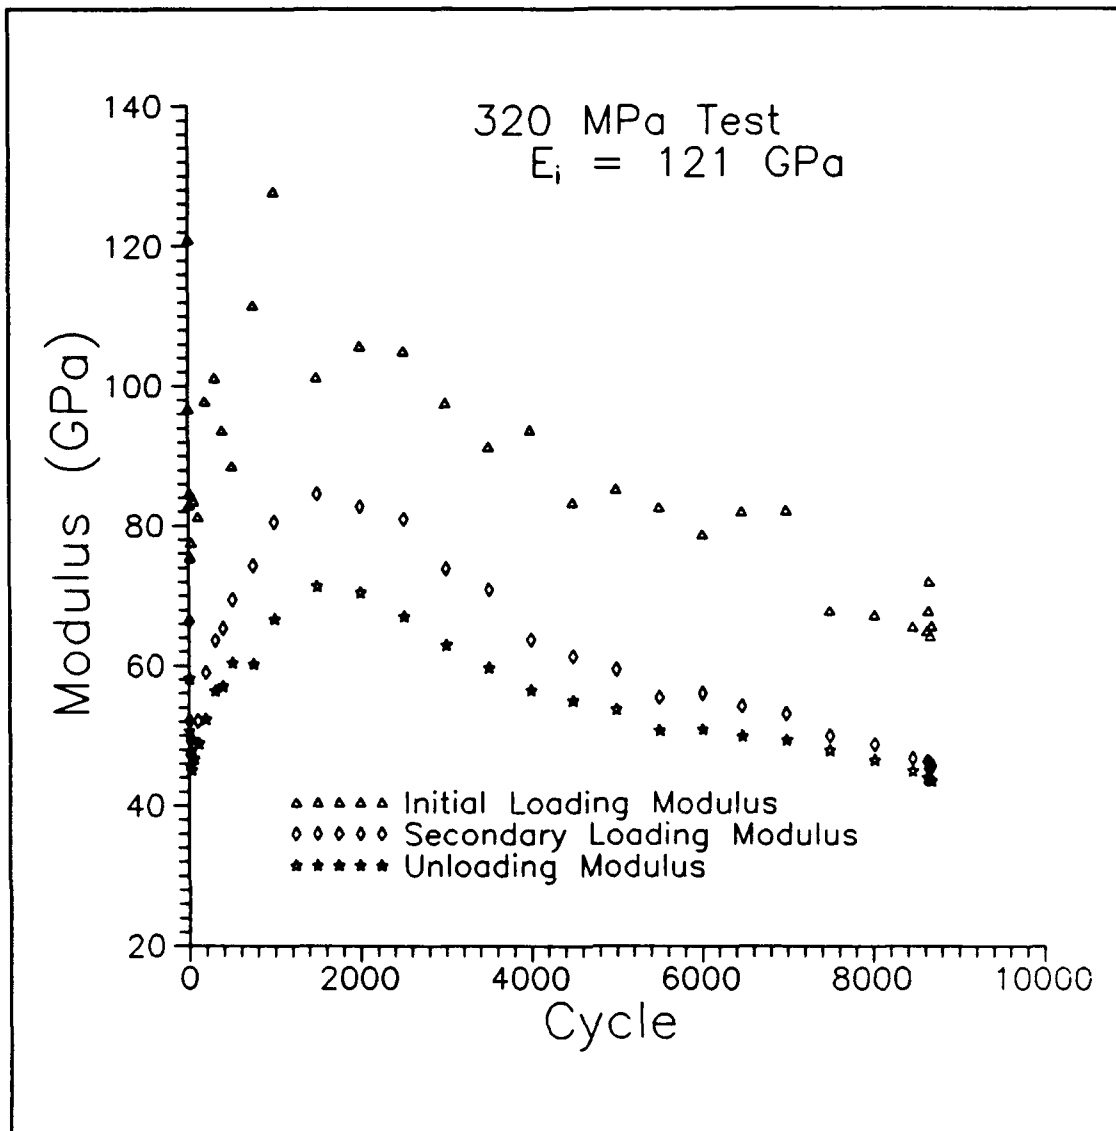
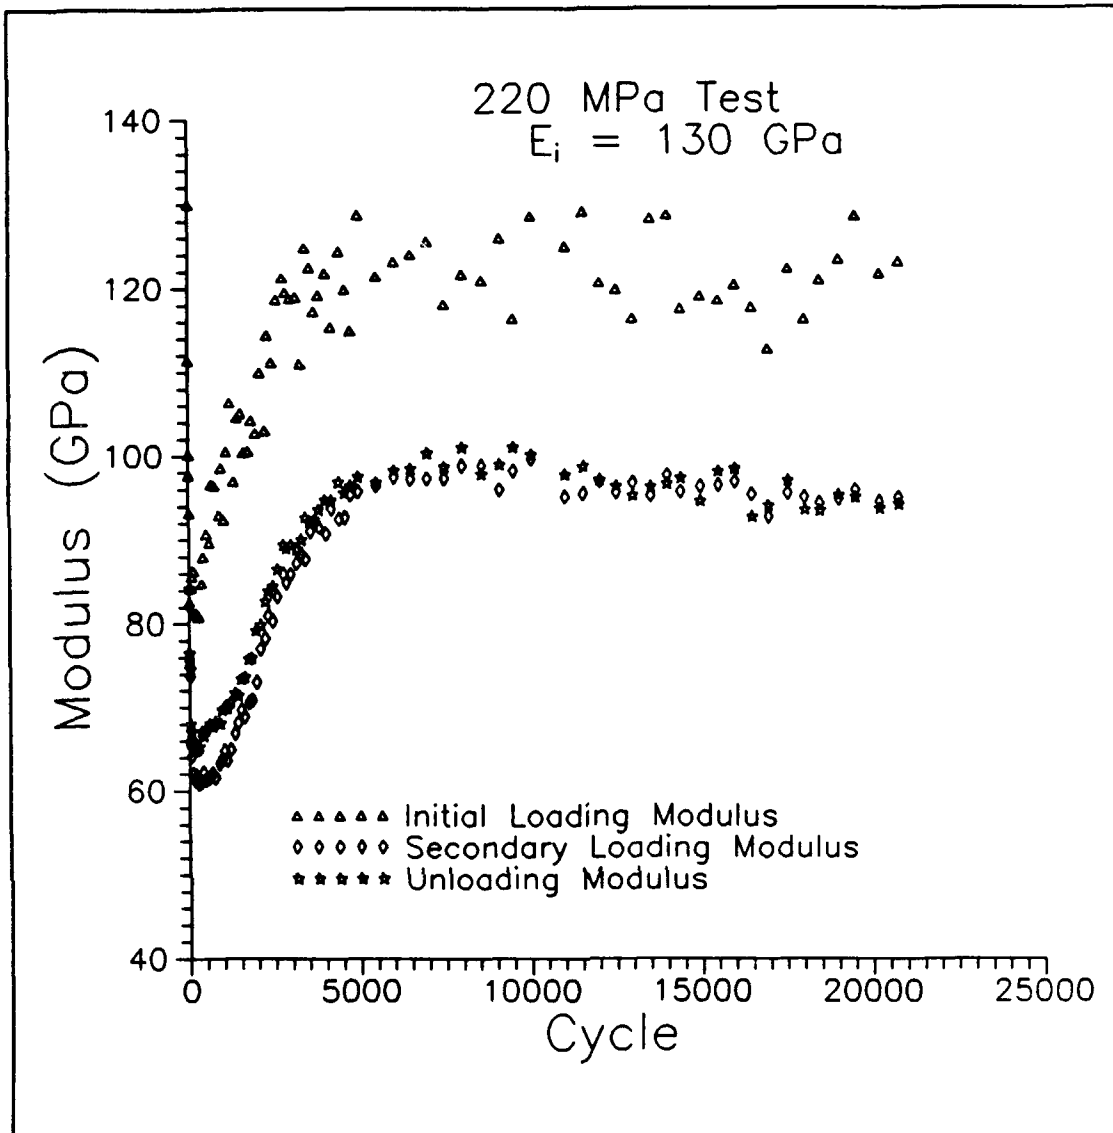
Three distinct trends common to all moduli can be seen during cycle life (with the exception of the 450 MPa test). First, there is a sharp and dramatic decrease in the stiffness during the first 10 to 50 cycles. For the initial loading modulus, this corresponded to about a 20 percent drop from the uncycled value. The decrease in the other moduli was not as severe, but averaged between 10 to 15 percent. The second trend is a period of stable stiffness increase continuing for 1000 to 2000 cycles. This hardening period resulted in the initial loading modulus recovering most of the early losses and approaching the original uncycled value. The secondary loading modulus and the unloading modulus also experienced gains of similar magnitude. The 450 MPa test did not show this trend, though failure

Figure 25. Modulii for 450 MPa Test

occurred after only 33 cycles. The 220 MPa test exhibited stiffness increase for 5000 cycles. In each test, the increase occurred in all modulii over the same period. This precludes the possibility of the increase being an effect caused by a poor linear fit and implies that the composite as a whole experienced a stiffness change. The last trend

Figure 26. Modulii for 400 MPa Test

is a gradual decline in all three modulii until failure. Appendix A contains modulii plots on a logarithmic cycle axis which more clearly shows the early stiffness loss. The stiffness does not abruptly decline as failure approaches which indicates a sudden fracture. The 450 MPa test did not exhibit a gradual stiffness decrease after the hardening

Figure 27. Moduli for 350 MPa Test

This general trend of a drop in stiffness, followed by a rapid increase and then gradual decrease in stiffness was

Figure 28. Modulii for 320 MPa Test

In each modulii plot, the initial loading modulus shows a large band of scatter with the modulus varying widely

Figure 29. Modulii for 220 MPa Test

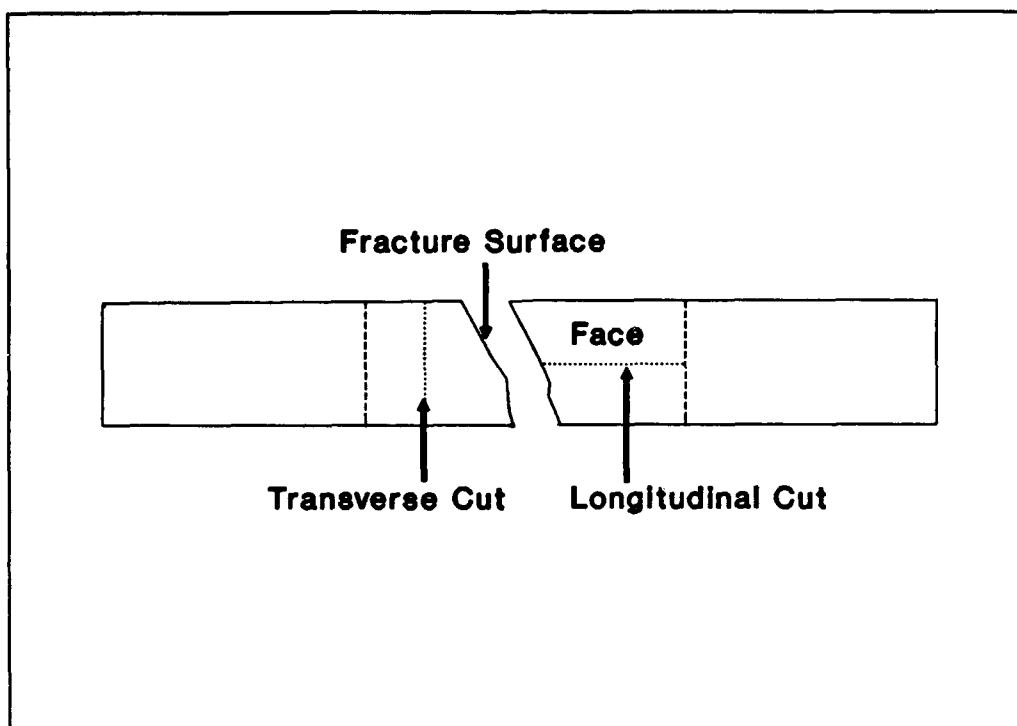
Before specimens were prepared for fracture analysis, an X-ray was taken to reveal any fiber rotation which may have occurred during testing. Fiber rotation was a possibility due to the large longitudinal plastic strains and the related necking. Each failed specimen was then sectioned near the fracture surface into four pieces which could be individually examined. The fracture surface was cut off to a size suitable for the SEM and saved for later SEM examination. A transverse cut just behind the fracture surface and a longitudinal cut through the fracture surface was made. The longitudinal cut yielded two sections: one for through the thickness examination and the other for examination of the top face surface. Figure 30 shows a schematic of the section cuts. When the outer layer of matrix material was ground away from the face section, the entire length of the

Figure 30. Schematic of Sectioned Specimen

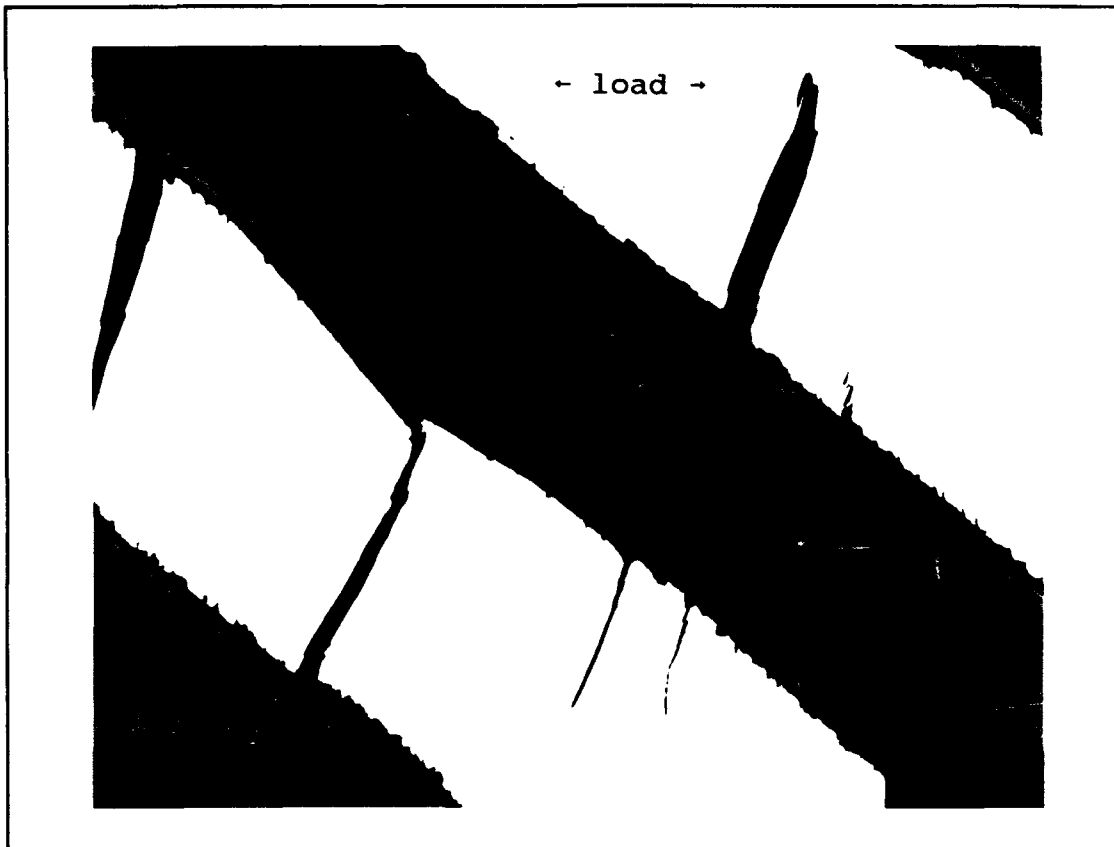
Figure 33. Matrix Cracking in the IF Test Specimen (300x)

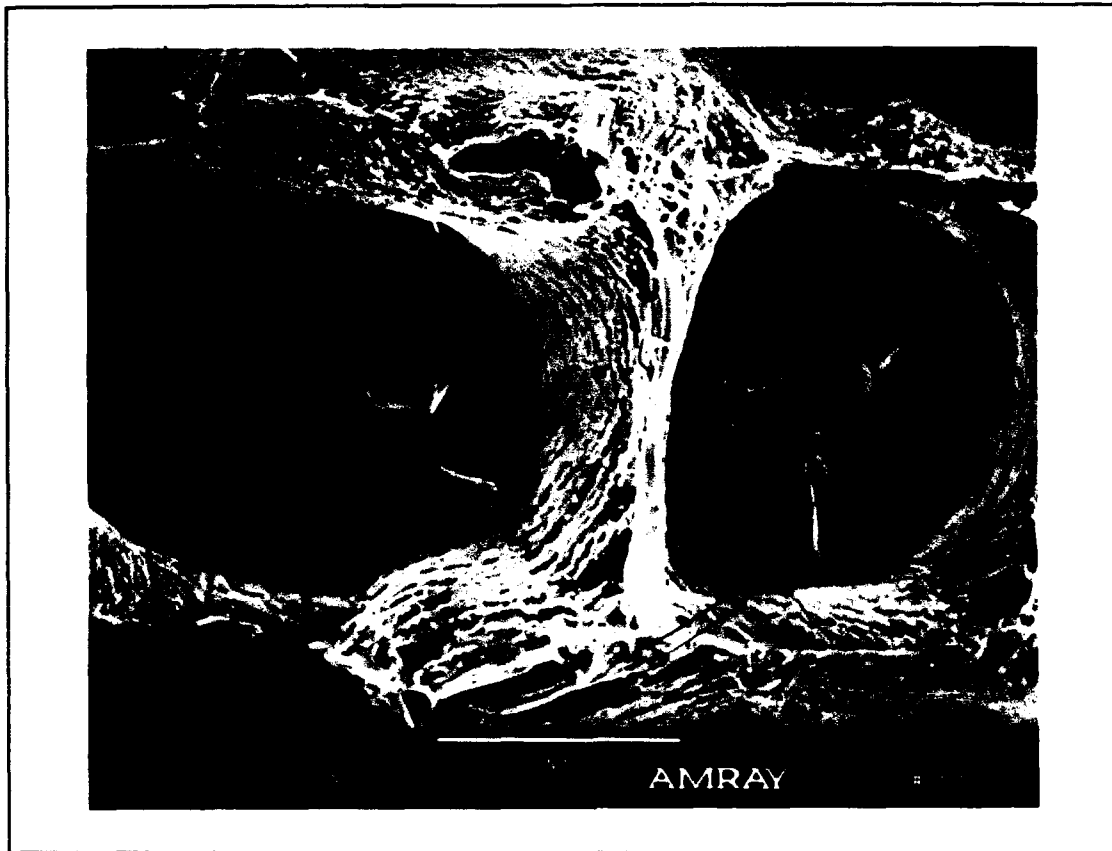
SEM analysis of the fracture surface revealed a fracture surface dominated by ductile characteristics. Figure 35 shows a SEM photograph from the fracture surface. The

Figure 35. Ductile Fracture Surface of the IF Test Specimen
